PRELIMINARY REPORT

Document Ref	FTCS: 26-06
Date	13/03/2026
Version	01

On 4th March 2026, an incident occurred involving Falcon Tower Crane Services tower crane TC510 (JASO J168HPA - Serial No. 0124) located at the Hill Group Barlby Road development, London.

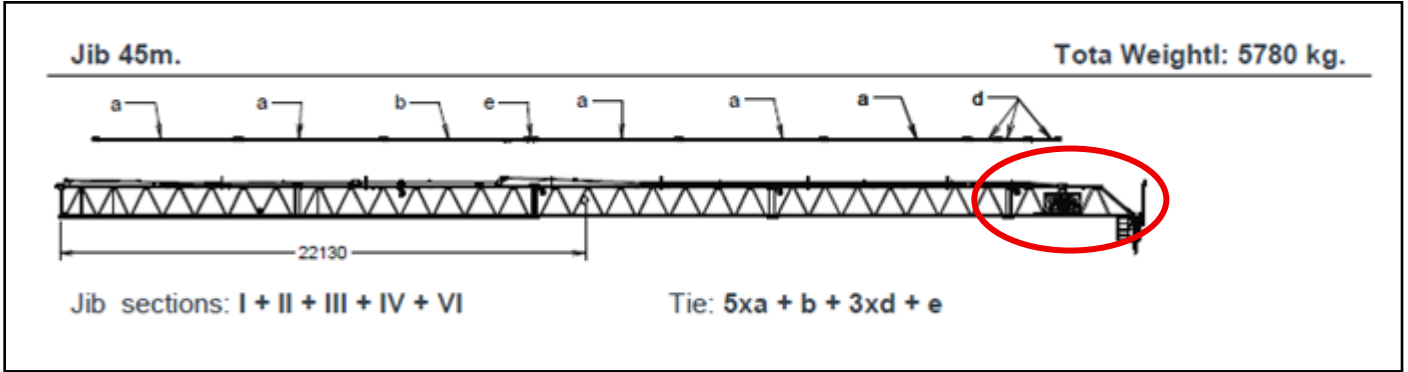
Photo 1. Collapsed Jib

The lower right-hand chord fractured, and the jib spine buckled as a result of the jib connection pin separating from the lower left chord (4 and 6). The jib tie connection caused jib section 6 to invert.

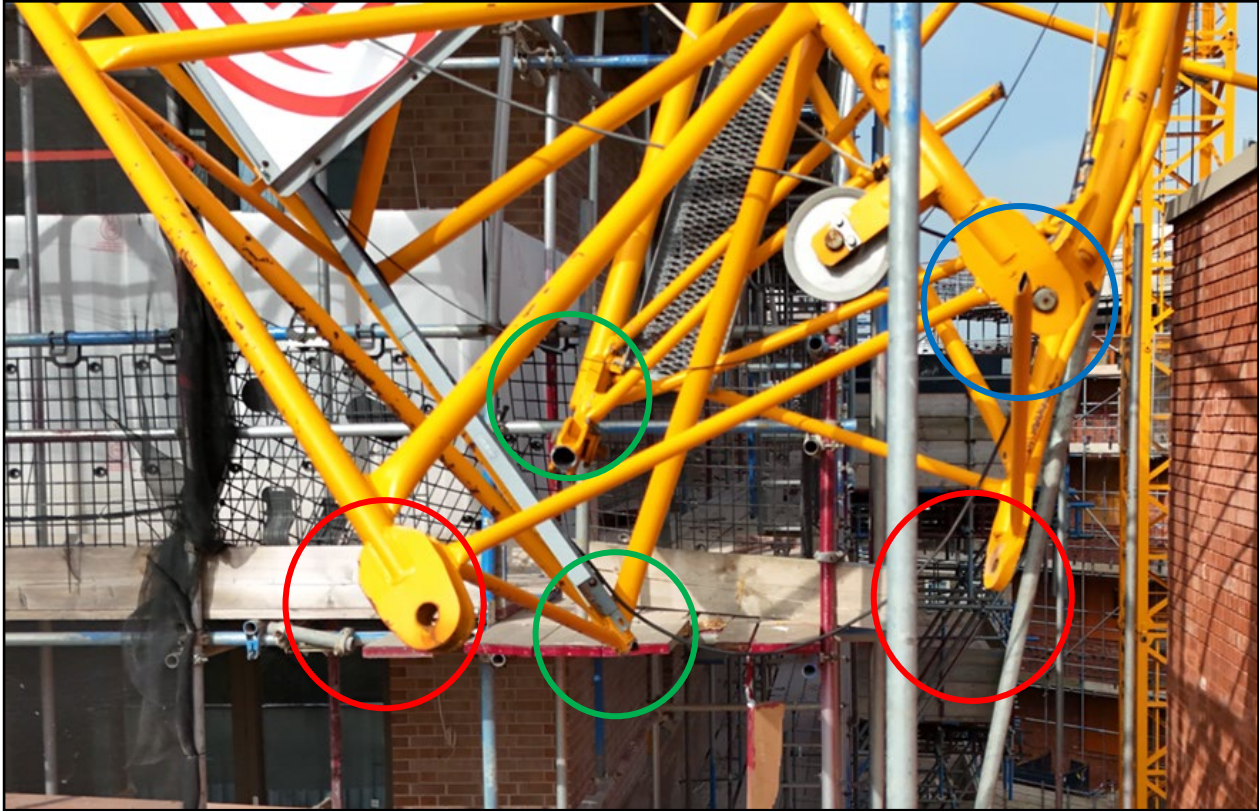
Markings found on the underside of the jib are consistent with repeated hook block strikes around sections 4 and 6 of the lower chord connections. This includes impact markings on the pin securing mechanism, as detailed below.

The hook block has struck the retaining pin, dislodging it from the retaining mechanism, allowing the jib pin to separate from the lower side left chord connection of sections 4 and 6.

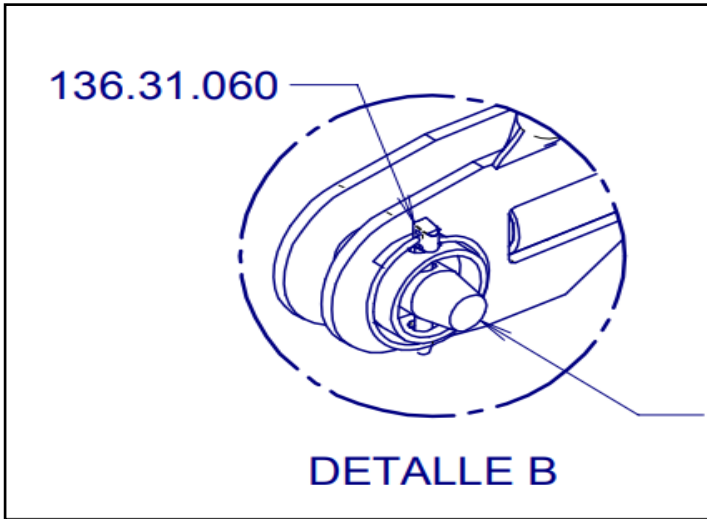
The image below shows the manufacturer's current pin retention mechanism, utilising a spring-loaded lynch pin.

Tower crane components which cannot be accessed for visual inspection by the operator will be retained with a clevis and cotter pin, utilising the manufacturer's retaining mechanism framework.
