SERVICE BULLETIN #101

FROM: Product Safety Department
DATE: 10th May 2011
SUBJECT: Jib Linkage Inspection
MODELS AFFECTED: H16TPX, HA120PX, HA12IP, HA15IP, HA16PE, HA16PX,
HA16SPX, HA18PX, HA18SPX
PART AFFECTED: Jib Linkage 138P236920

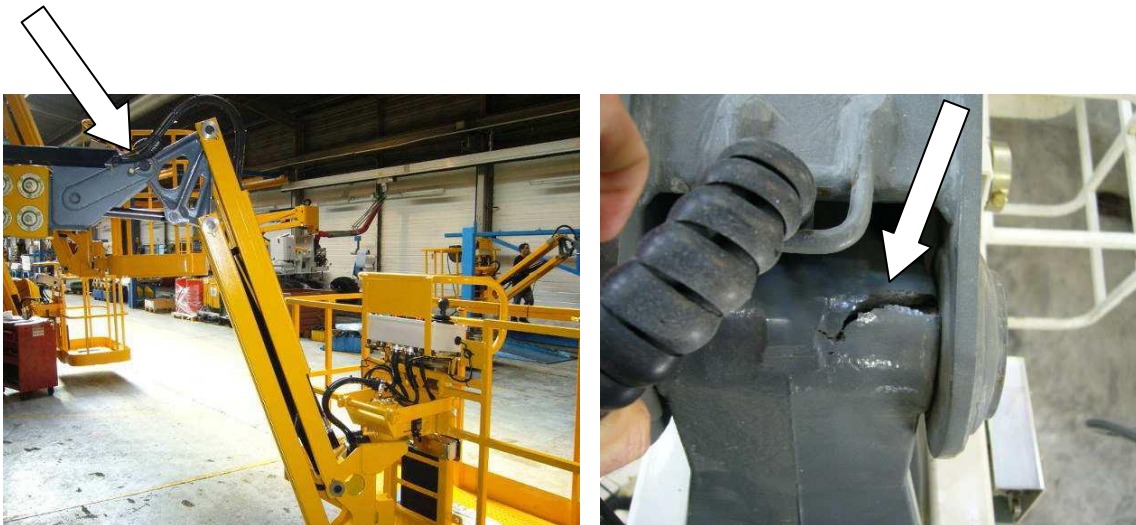
Haulotte continually monitors the quality and safety of its products. We would like to draw your attention to a progressive component failure, below, which has been either missed or ignored during the routine inspection process set out in the manual supplied with the product.

As with products of this type it is possible to subject the jib/link to high shock loads, for example by impact with fixed objects. In the event that the operator/owner has a suspicion that such an impact has taken place, the entire mechanism from the link back to the basket must be carefully inspected with particular attention being paid to the link piece which is the subject of this bulletin. The inspection must include the metal casting linkage that could crack in the area shown in the pictures below. As a matter of normal precaution, it is recommended that the jib linkage should be checked during each routine inspection, off-hire and pre-hire control processes.

In the event that the jib linkage is found to be damaged, the machine must be removed from service and the link replaced without delay before using the machine again.
