A used tank container with a stainless steel barrel is used as basis for the rebuild bitumen tank container.

5 Year Periodic Test Certificate for ISO Portable Tank

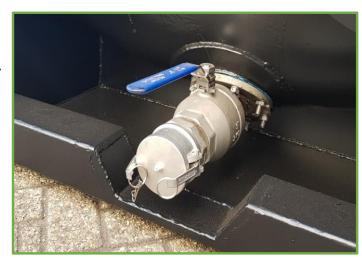
Valve & temperature

A new 3"BSP bottom ball valve is installed. This is the most common valve used for bitumen products.

The valve is heat proof up to 300 degrees Celsius.

Camlock can be fitted and is optional.

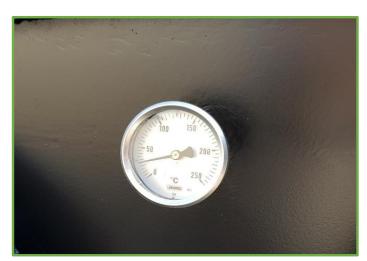
Also a new temperature meter is installed which can indicate a temperature up to 250 Degrees Celsius.

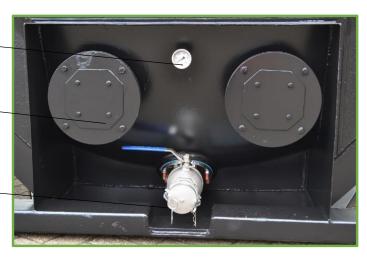
Temperature measuring

Flame tubes for connection of the burners

3 inch BSP treated bottom outlet -

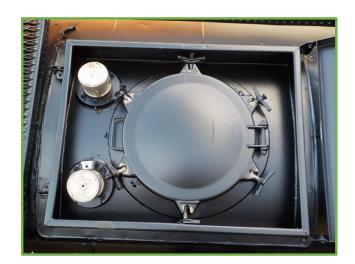
Top of the bitumen tank

Pressure relief valves are refurbished and installed. And of course set on the right settings.

The manlid and other valve are fitted with new gaskets.

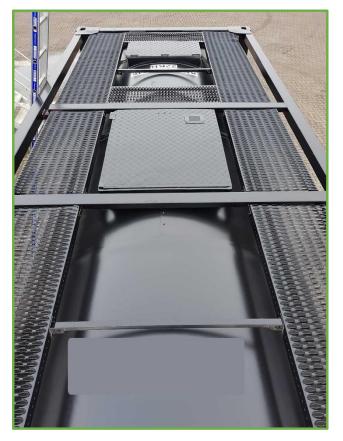
Walkways, cladding (50mm thick) and frame are refurbished to an acceptable level for certification and cosmetic purpose as well. All decals are replaced and the tank is painted in a black colour.

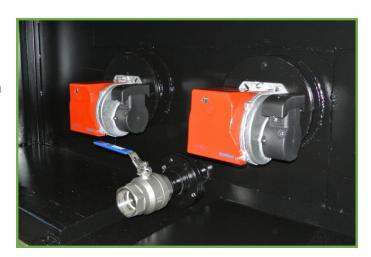
Burners & cargo

The fully loaded tank can be heated within 10 hours.

These diesel burners can be transported inside the empty tanks or transported separate when the tank in loaded.

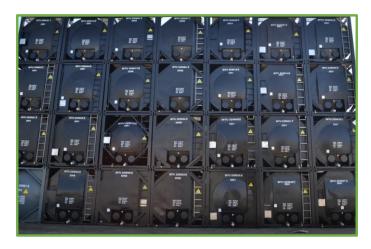
Bitumen tanks are dedicated to the bitumen cargo and the tanks are difficult to clean.

After unloading a residue will be left under the flame tubes and at the walls.
