Marsh Restoration Project Overview

Airborne Sensor Platforms

Post Processing of Photographic data

Water Depth Logger Network Specifics

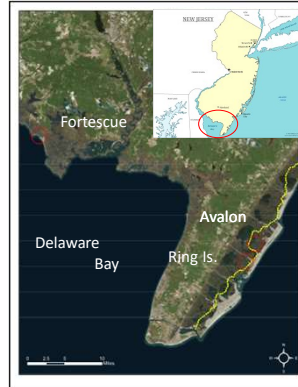
Pictured here is an example of the deposition process

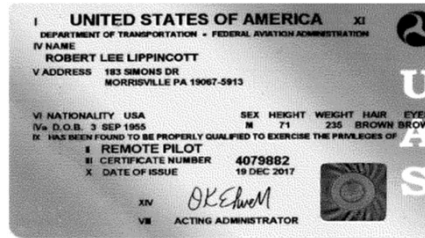
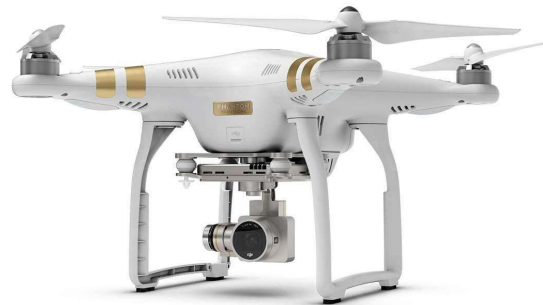
Quadcopter Drone Used In This Research

- DJI Phantom Pro
- ~20 minute battery life
- Autonomous Flight Path
 - Drone returns when battery life is low
 - After battery replacement it continues the preprogrammed flight plan
- 3 FAA Part 107 Certified small Unmanned Aircraft Systems (sUAS) pilots onsite
- 2 Line of site Visual Observers
- 12 Megapixel Visible and multispectral camera

There are FAA part 107 rule to comply with when flying drones. Waivers must be obtained and permission granted from several federal, state, and local sources before the aerial survey can begin. In this research we take a team of Part 107 Certified pilots in addition to two visual observers to ensure compliance with the flight rules and other requirements to conduct the work. We take multiple batteries to accomplish the entire flight and the drone returns to the starting point automatically when low battery status is indicated. The battery is then changed and the drone returns to its pre programmed point to continue the aerial programmed flight path .

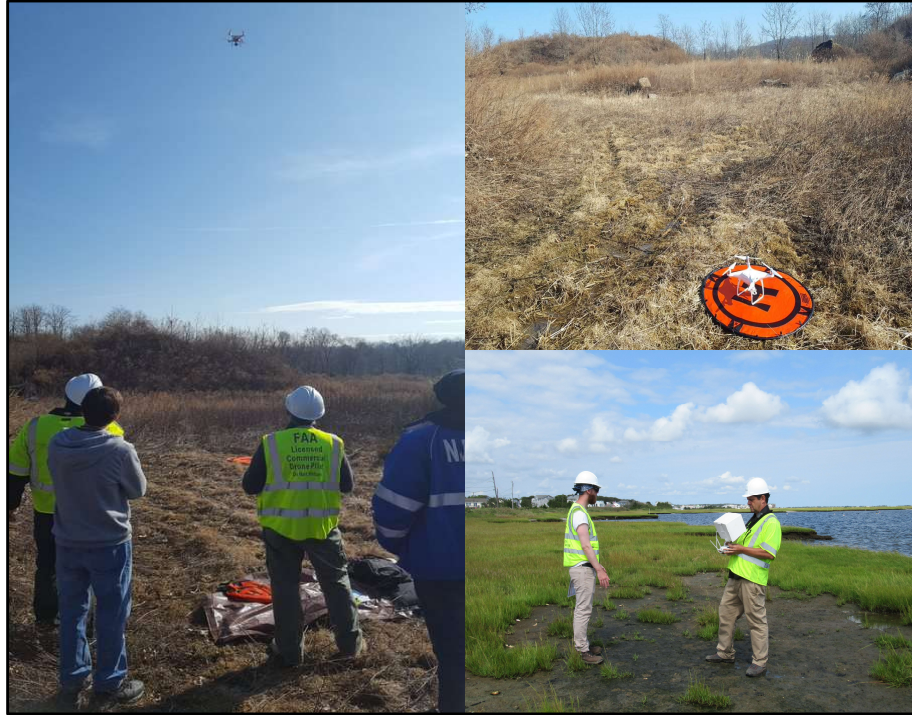
Here are some pictures of the flight crews on a bright sunny day. Actually the drone pilots prefer overcast days because it provides a more uniform Orthomosaic Raster surface product without periods of sun and clouds.

In the upper right picture you see the drone landing pad, usually the drone can return to the landing pad for battery exchange but if the winds are too strong (in excess of 15 knots) a safe landing may be compromised and damage the drone from collision with the terrain can occur.

The lower right photo shows the quad coptor mavic drone crew at Ring Island. This drone has the infrared camera capability

The left photo shows the pilots in yellow vests with the hardhats and the visual observers that are required to comply with the FAA regulations.

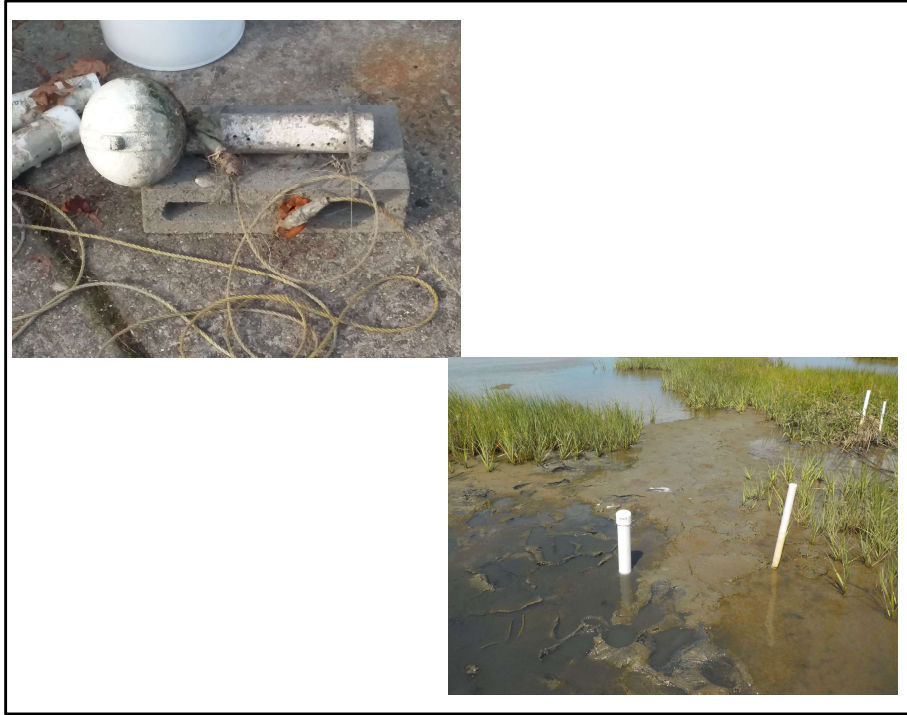
This slide illustrates the construction housing for the submerged pressure sensors that were deployed in one tributary at each of the three (3) locations. Loggers were suspended horizontally by wire inside a 2" by 1' PVC pipe with holes drilled along its length for drainage. The PVC pipe containing the logger was secured to a half cinderblock with zip ties and an eyebolt was attached to secure a length of rope and a float.

Water level at deployment and recovery were measured with a ruler along with RTK GPS position for each of the submerged loggers. At one location, the cinderblock also served as a habitat for two juvenile oyster cracker fish that refused to leave the block as we downloaded the data from the logger!

The lower right photograph is a picture of a monitoring well that was installed. The sensors were attached by wire to a hole in the side of the PVC pipe at a depth below the low tide water level.

- Each Study Area had an Air Pressure Reference Onset Hobo pressure logger that was wired into a 2" PVC pipe with a top cap and attached to a post at a level of 5 feet AGL.
- All Monitoring Wells were collocated next to the ground elevation measuring stations in the deposition areas.
 - The wells were 2" x 5' slotted PVC pipe with cone shaped end cap and installed at low tide
 - The depth was deeper than low ground water level so that sensor was continuously submerged
