PRELIMINARY REPORT

Document Ref	FTCS: 26-06
Date	13/03/2026
Version	01

On 4th March 2026, an incident occurred involving Falcon Tower Crane Services tower crane TC510 (JASO J168HPA - Serial No. 0124) located at the Hill Group Barlby Road development, London.

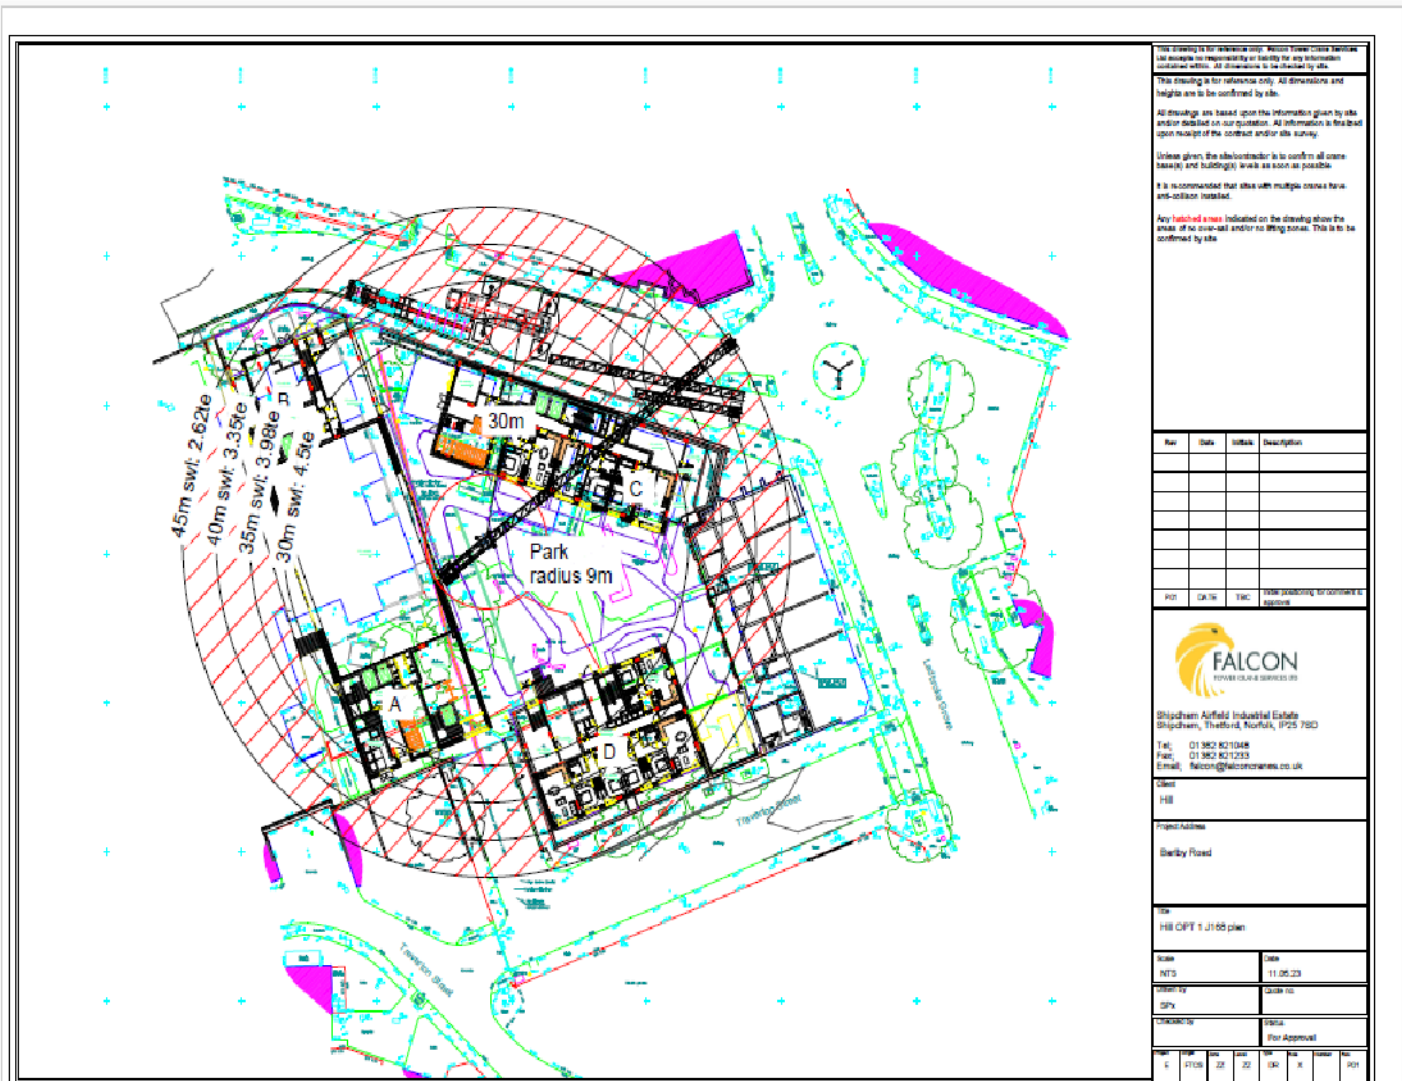
Site Plan Drawing

Time	Event
09:45	Lifting operations commence
09:50	Five lifts completed (maximum load approx. 2500kg)
09:52	Empty brick cage (approx. 450kg) lowered to the ground
09:53	The Jib connection pin separates from the lower left connection
	The Jib structure collapses onto the scaffold within the site boundary
	The Hook block falls into the brick cage
09:54	The crane operator applies the emergency stop button and descends the crane
Immediately after	The site was evacuated and the area secured
